Final report RL 2013:10e

**Incident on 2 February 2012
involving the aircraft SE-DSX
after take-off from Bromma
Airport, Stockholm County.**

Ref no L-16/12
30-04-2013

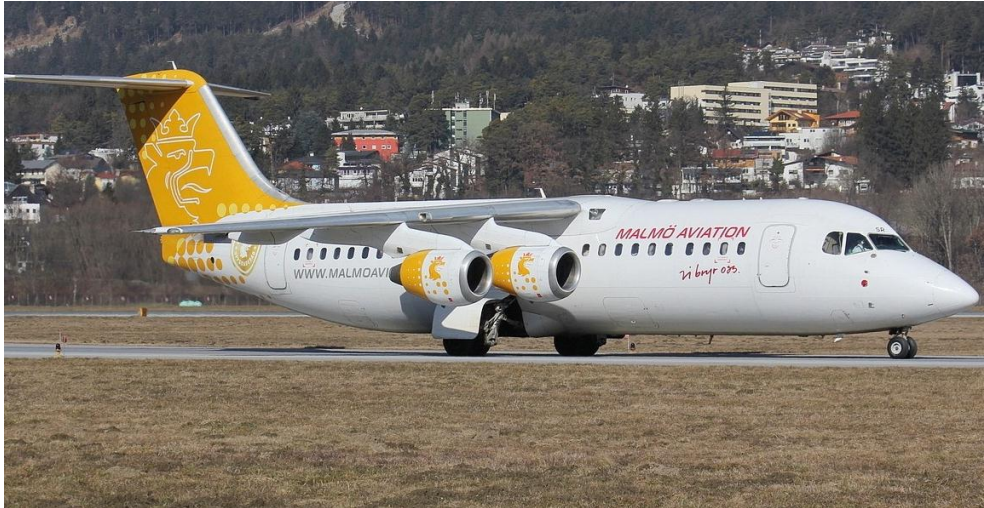
Fig. 1. RJ 100. Photo: Thomas Rosskopf.

The aircraft is a passenger aircraft with four jet engines of the type Lycoming (Honeywell) LF507-F1. In the technical checks carried out by the operator after the incident, no technical faults could be found in the aircraft, for which reason SHK's investigation has been limited with respect to other technical documentation.
